Admiral Safety Ltd

| Issue Ref: | HSE Information Sheet - 0008 |
| Topic: | Entrapment whilst working from Mobile Elevated Working Platform (MEWP) |

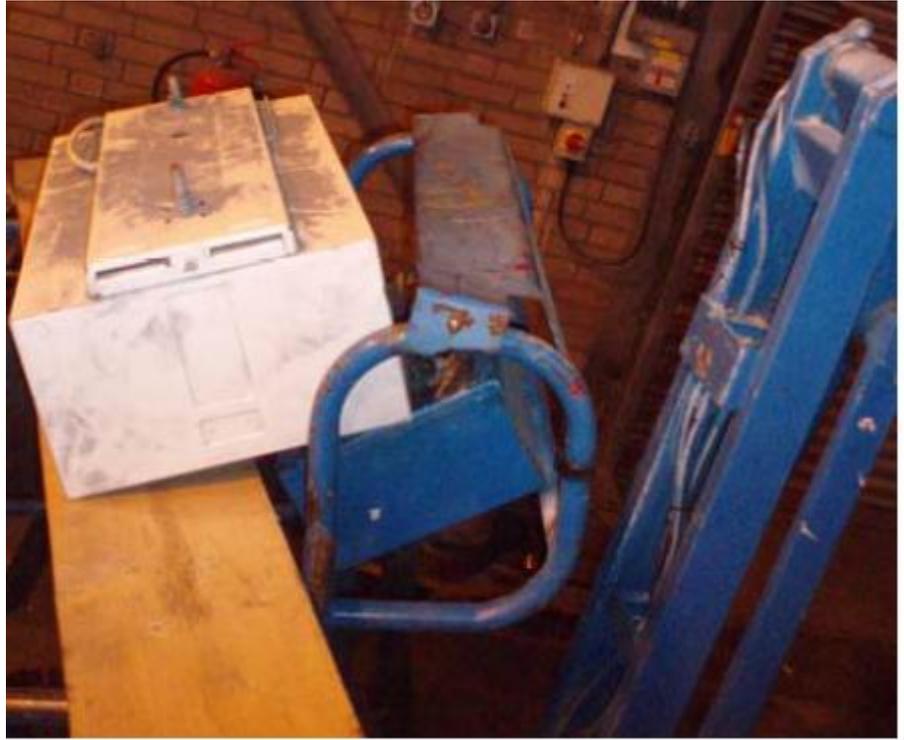
Picture:

| Details: Source ESCS | <p>A worker was injured and left unconscious when the controls of the MEWP he was using were inadvertently activated</p> <p>On Thursday 3 November 2011 a two man team were deployed to fitting refurbished lamps in a Boiler House at a height of circa 7m. The work was being conducted by a single man from the basket of a Mobile Elevated Working Platform (MEWP) 'cherry-picker', whilst his colleague was deployed in an emergency standby role.</p> <p>The Injured Party (IP), who was working with his head above an adjacent redundant fire main, had just finished connecting the refurbished lamp to the lighting system and had then lifted the fitting onto a pair of suspension chains that were attached to a bracket at roof level.</p> <p>The IP did not realise that he had rested the fitting on the guard covering the machine controls which left slack in the suspension chains. As he activated the fly jib tilt switch the fitting "slid off" the guard activating the MEWP track handle.</p> <p>The MEWP moved forwards at a speed of about 0.1mph trapping the back of the IP's neck against the redundant water main, it is suspected that this entrapment affected the IP's blood supply to his brain, causing him to lose consciousness.</p> <p>His colleague at ground level immediately reacted and isolated the machine by depressing the emergency stop at ground level before lowering the elevated platform of the MEWP to the ground. On his release from the entrapment the IP quickly recovered consciousness. He was given First Aid Treatment on site for a cut to his nose before being taken to Accident and Emergency (A&E) for a full assessment.</p> <p>The IP returned to work the same day having been released from A&E although the incident was RIDDOR reportable</p> |

Position of lamp fitting, which slipped to operate the MEWP tracking handle

| Recommended Action: | <p>Consider the quarantine all MEWPs which do not have a platform control panel protective guard.</p> <p>Ensure that suppliers of hired in MEWP check that the control guard is properly fitted.</p> <p>For company owned MEWPs ensure that the manufacturer checks that the control guard is properly fitted.</p> <p>Specify that any newly hired/purchased MEWPs come with a factory fitted control guard</p> |
